# CITY OF MUSKEGON

## CITY COMMISSION WORKSESSION

**C. 880 First St. Demolition- Asbestos Abatement Proposal** Economic  
Development

## **ASBESTOS NESHAP INSPECTION REPORT**

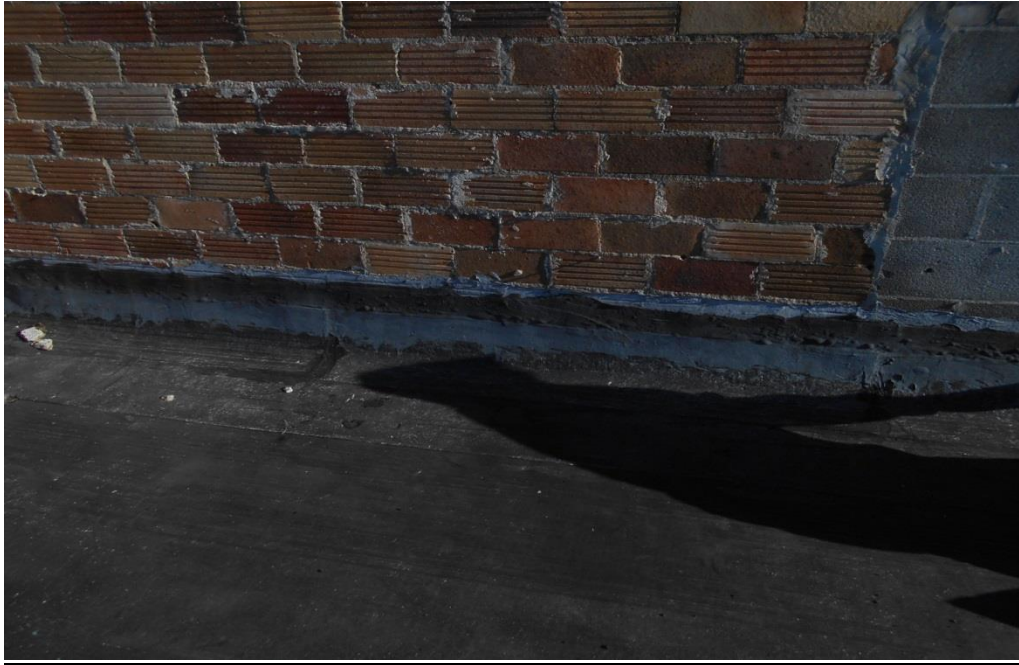
HA #1. Tar and Flashing Layers. On and Around Rooftop Elevator/Mechanical Room.

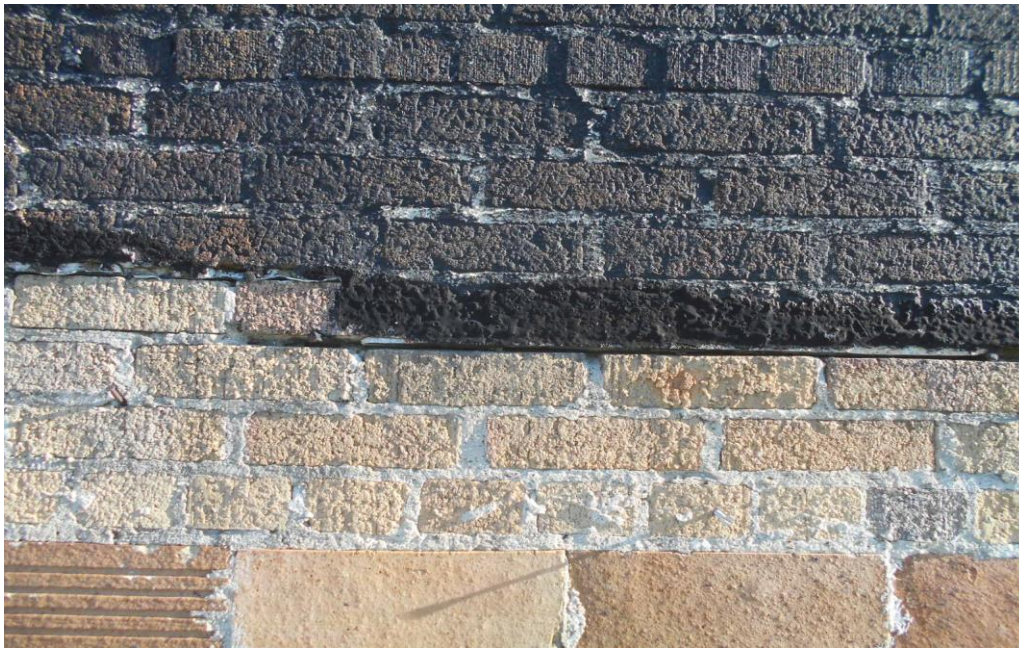
HA #5. Tar on Exterior of Rooftop Elevator/Mechanical Room.

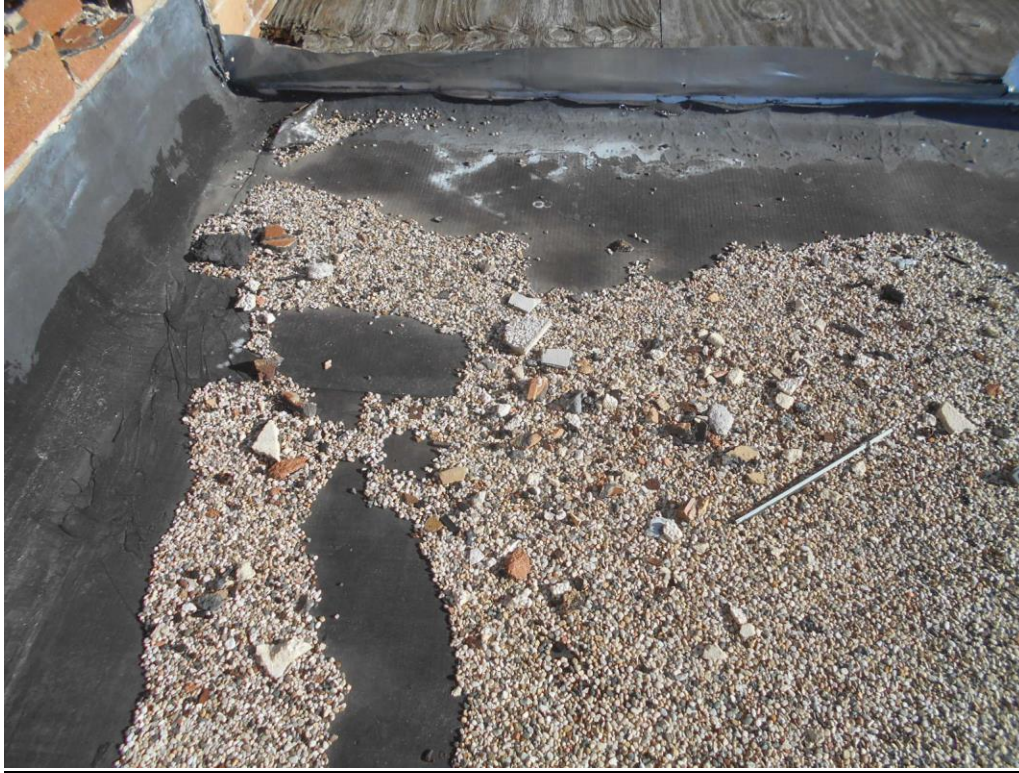
| <u>HA #</u> | <u>HA Description</u> | <u>Sample Location</u> | <u>Friable</u> | <u>ACM</u> | <u>Quantity Total</u> |
|---|---|---|---|---|---|
| 6 | Transite Debris | Loose Remnants near center area of Old Building Rooftop | No | Yes | 1 SF |

HA #6. Transite Debris on Older Building Roof.

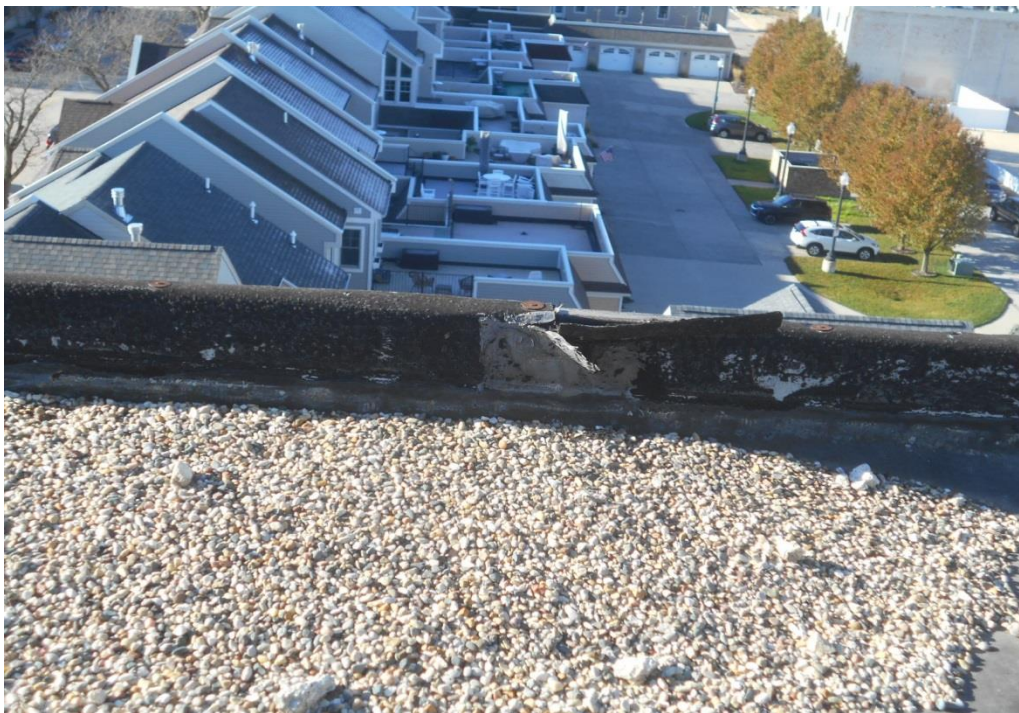
HA #7. Tar and Flashing around Perimeter of Older Building Roof.

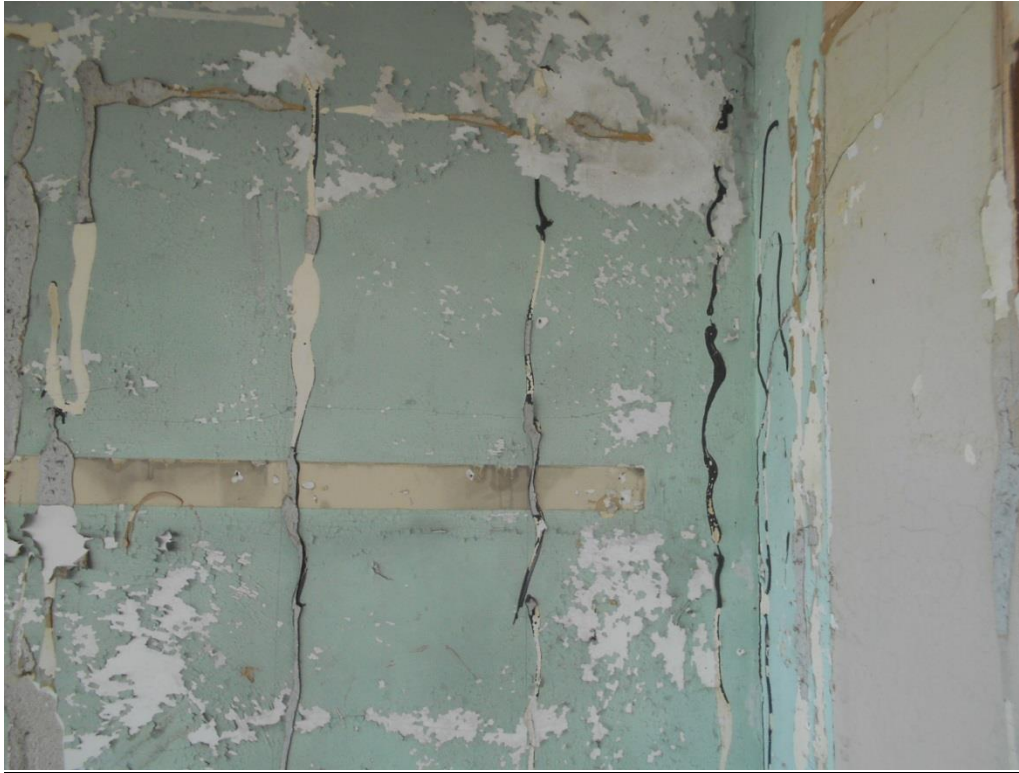
HA #12. Mastic on Plaster Walls (Behind Wallboard Systems)

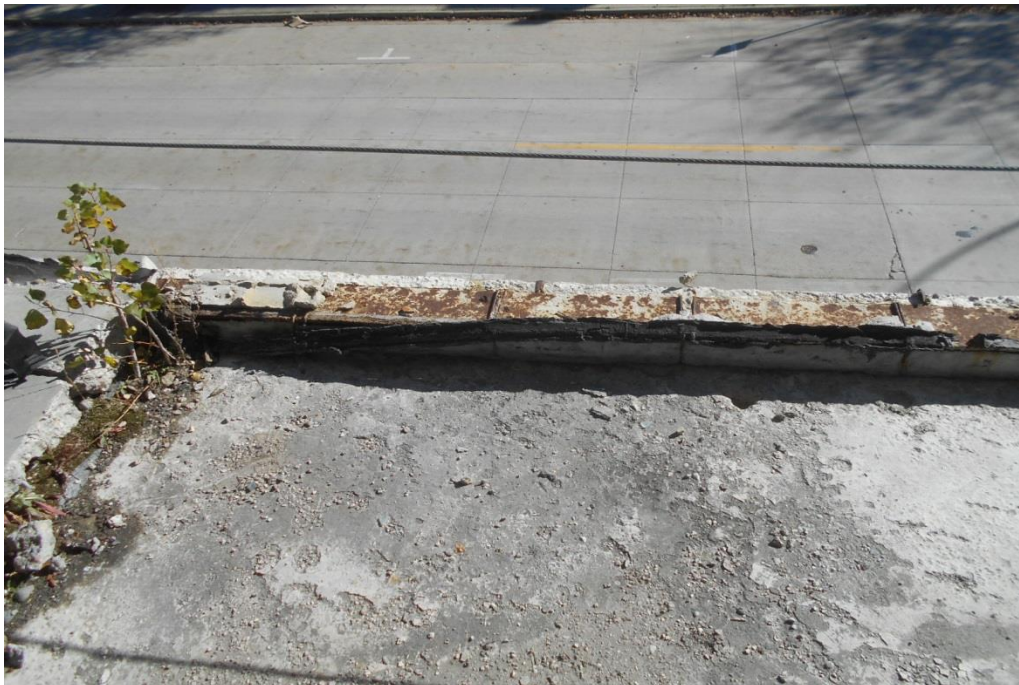
HA #22. Tar and Flashing at base of 2<sup>nd</sup> floor South wall near Stairwell.

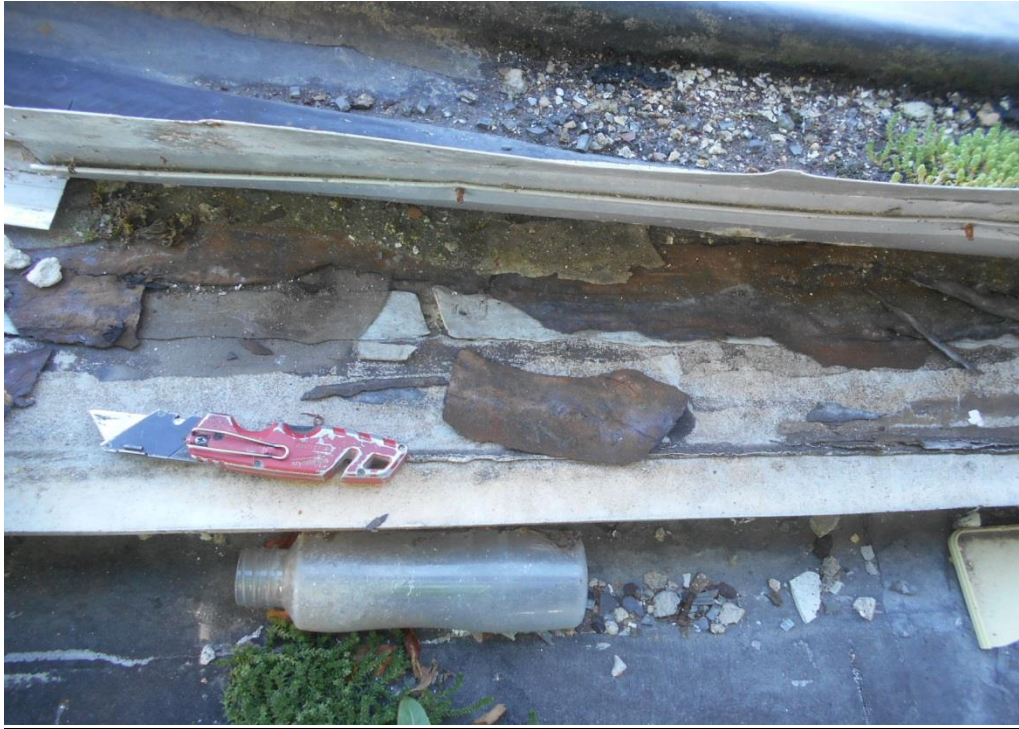
HA #23. Building Sealant (Gray) and Tar Layer (Black). 2<sup>nd</sup> Floor/Newer Addition Roof, below rubber roofing membrane.

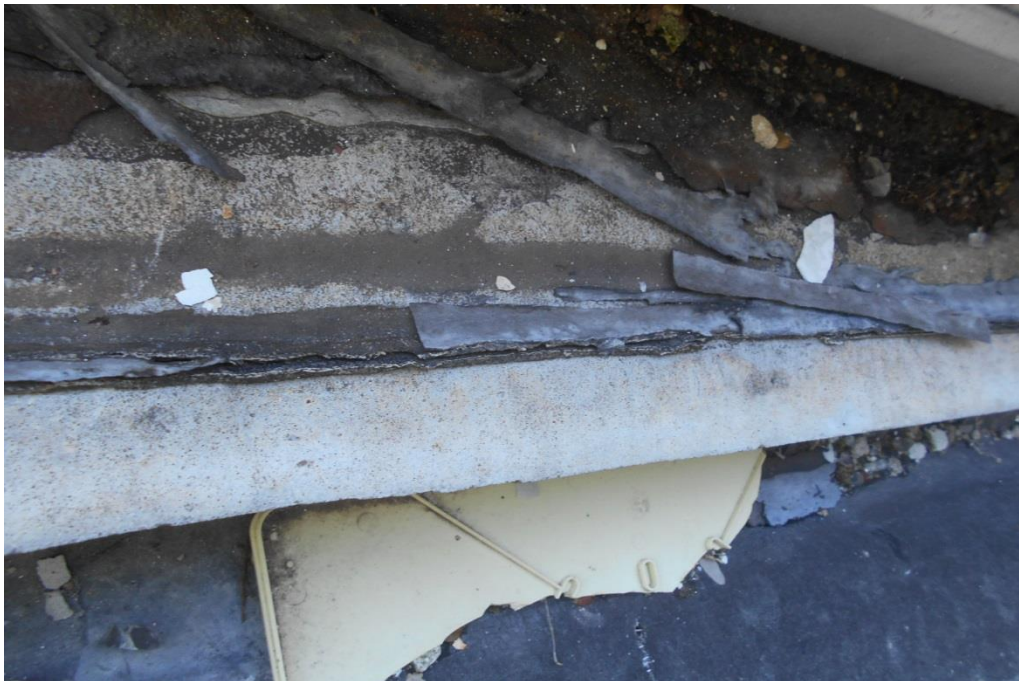
HA #24. Multiple Layers of Caulking/Sealants. 2<sup>nd</sup> Floor/Newer Addition Roof.

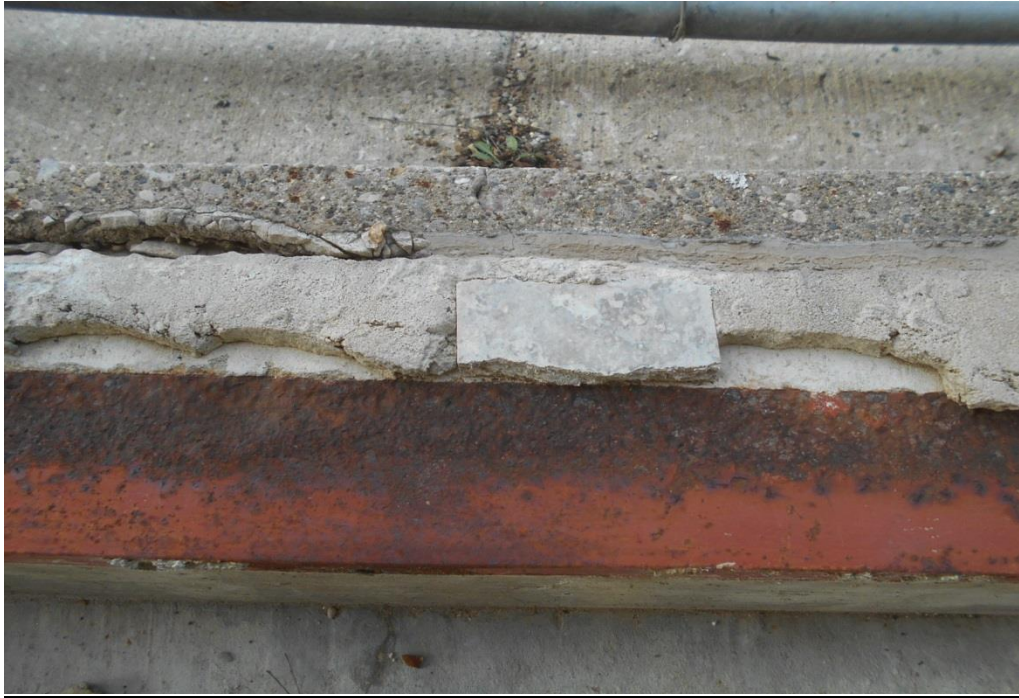
HA #29. Transite. Ground Floor of Older Building. Pieces stuck in Cement on Former Exterior Wall Foundations.

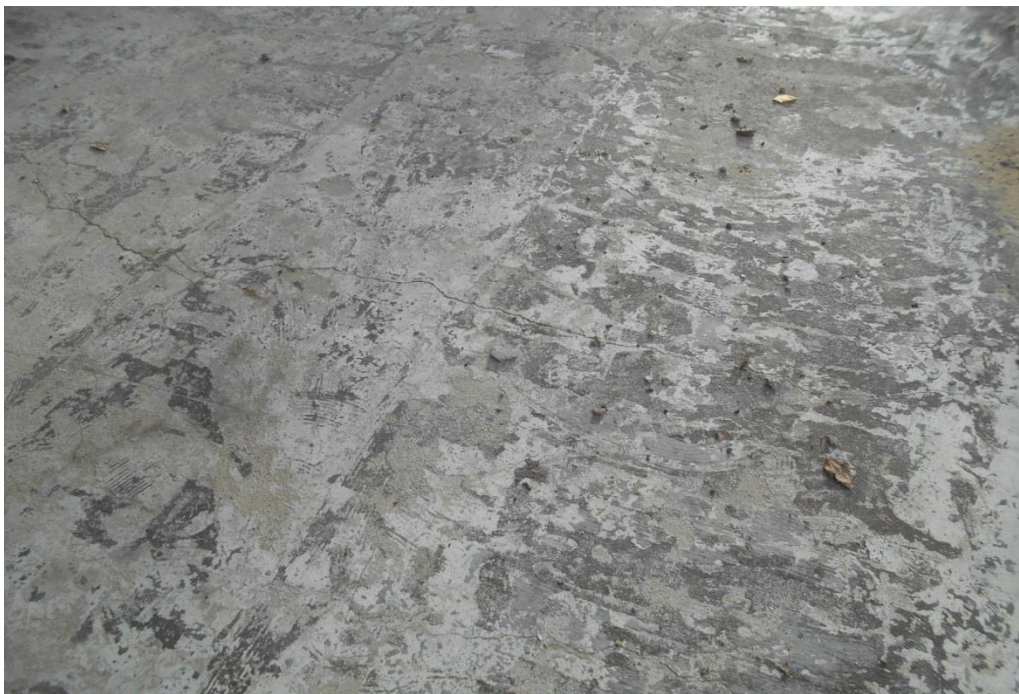
HA #32. Mastic, Black. Ground Floor Lobby.

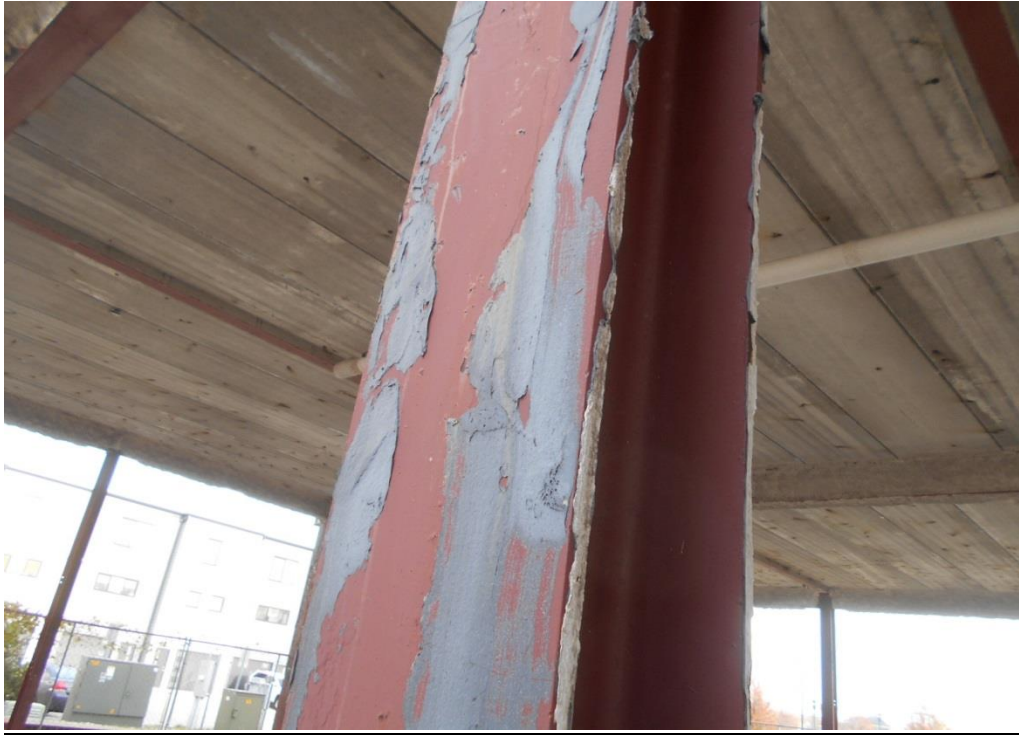
HA #34. Mastic on Steel Columns of Newer Addition.

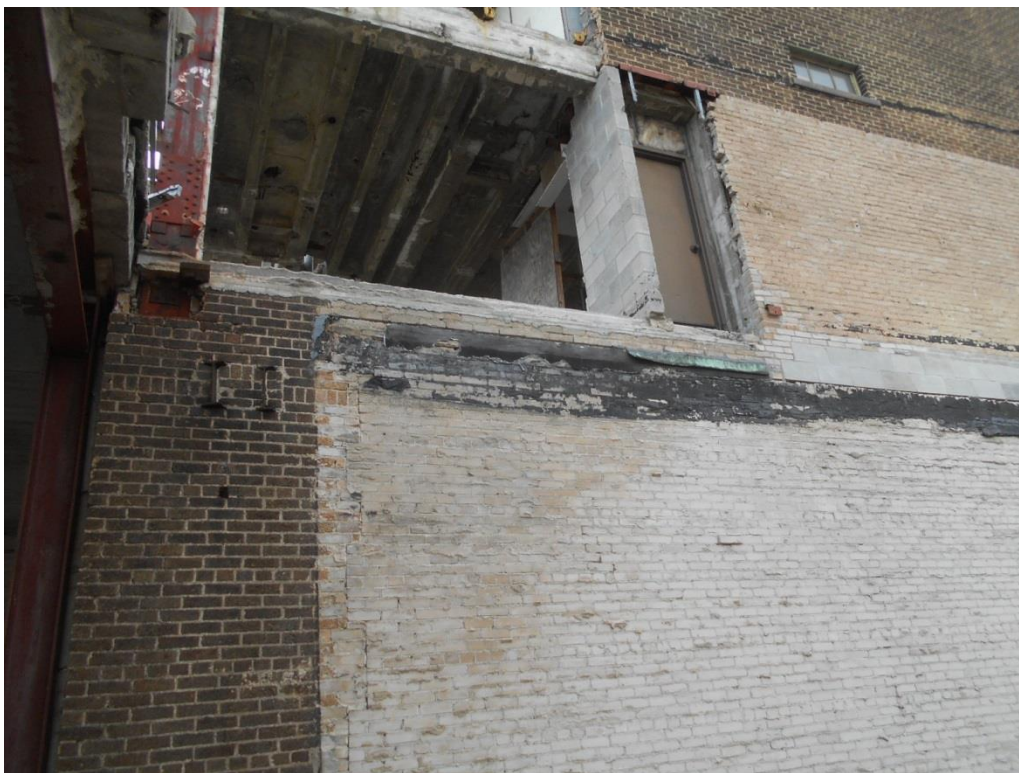
HA #35. Tar and Flashing on North Exterior wall of Older Section between 1<sup>st</sup> and 2<sup>nd</sup> Floors.

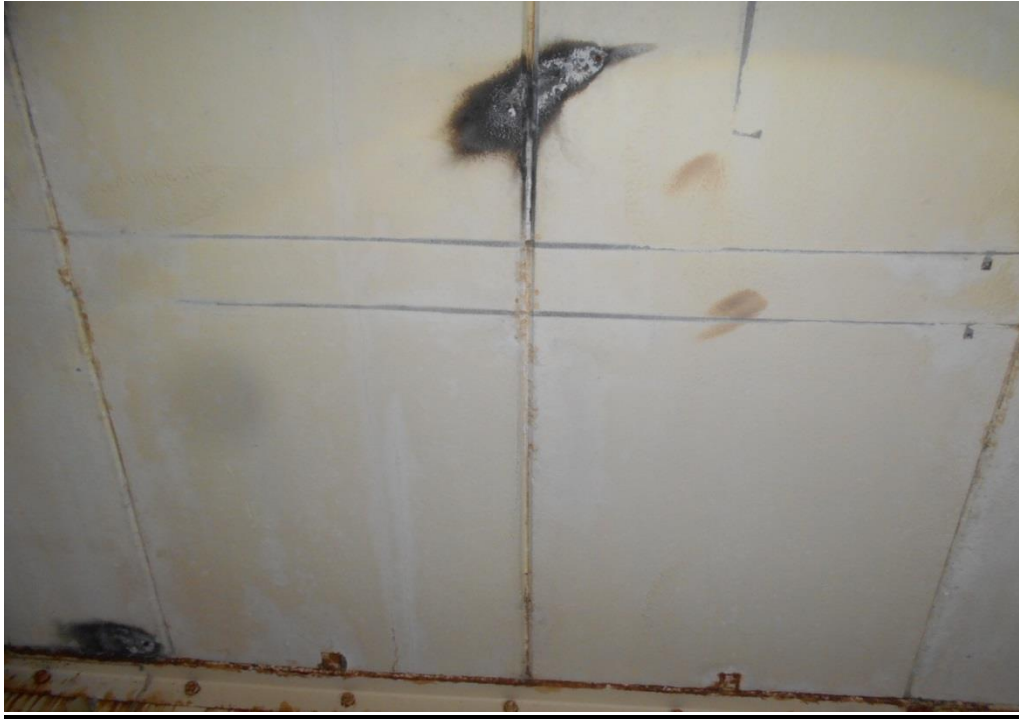
HA #47. Building Caulk, White. Between Precast Concrete Roof and Ceiling Decking on Newer Section of the Building.
